1202 Twist Lane

Salerno Lake

*Buyer Information
Package*

Home Inspection Report

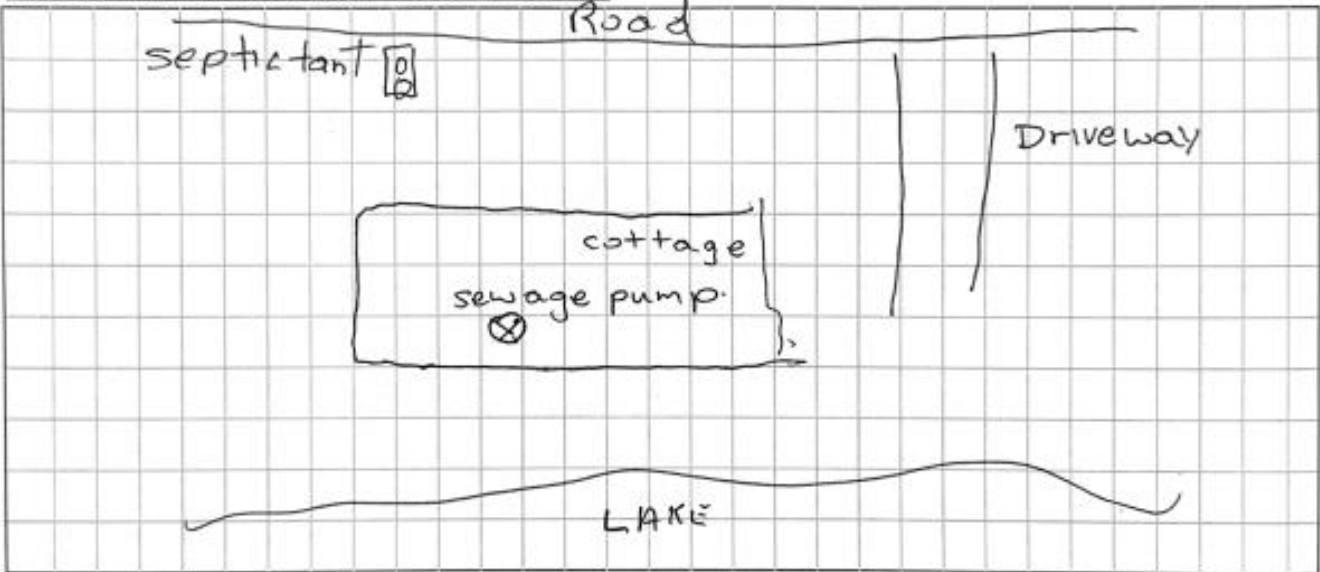
SKETCH AREA - LAYOUT OF SEPTIC SYSTEM

STATUS	OK	<u>CORROSION</u>	REPAIR/REPLACE	STATUS	OK	CORROSION	REPAIR/REPLACE
OUTLET			✓	ALARM			✓
INLET		✓		AUDIO/VISUAL			✓
PUMP	✓		upgrade	WIRING/GFCI		✓	✓
FLOAT	✓			LOCATION		below cottage

AT THE TIME OF THE INSPECTION THE SEPTIC TANK IS FREE OF STRUCTURAL DAMAGE & OPERATING AS INTENDED: YES NO
